WHITE CIRCLE NEWS

Summer 2021

Integral Construction and the Swindon DMU

Part One

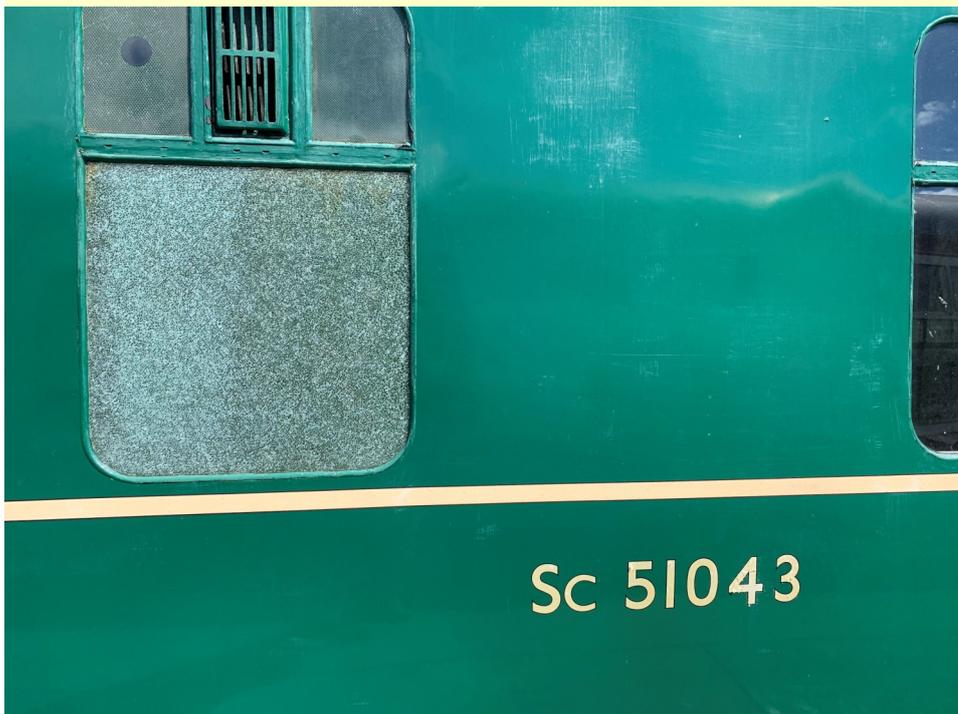
There is some news from Bo'ness, albeit bad. The toilet window on 51043 is broken—crazed is a better description—but it's thought not to be due to vandalism. Jim Ormiston informed us and supplied the picture on the front page.

Lower. Jim Ormiston alerted us to the fact that the toilet window on 51043 was “crazed”.

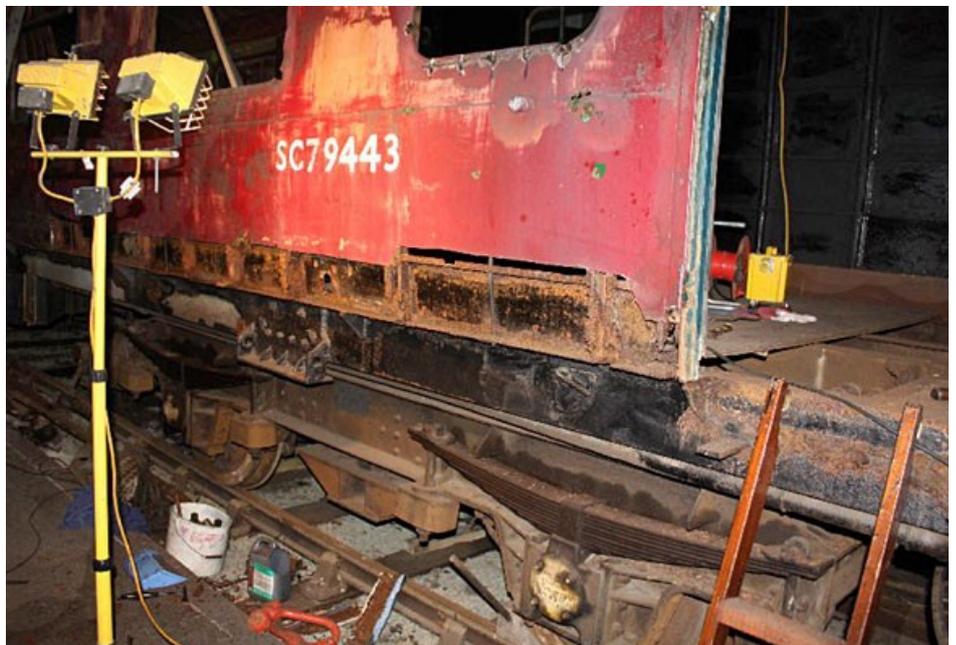
Cutting away the lower bodywork corrosion on Sc79443 – as seen in Image 1 – shows details of the construction techniques.

1. Edinburgh-Glasgow Inter-city DMU Buffet Car Sc79443 undergoing major bodywork rebuilding in the SRPS workshops. *Andy McConnell.*

Take a close look at the double skin steel forming the lower bodywork. It may not look like much, but the built up box section at the lower edge of the bodywork was a major improvement in terms of carriage design and it is no exaggeration to

Compare close up of the underside of the body to chassis joint of a standard Mk1 vehicle (Image 2) with the Box Sections shown on the two Swindon DMU photographs (1 and 3). On the Mk1 note that the frames (only) are joined to the chassis by outriggers. The body and chassis are effectively completely separate constructions. The underframe simply carries the body which in turn provides no strength to the chassis.

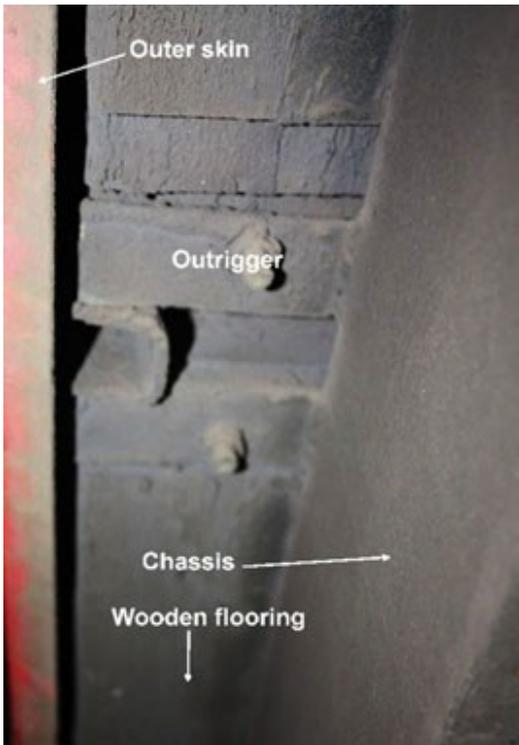
2. Looking upwards at the body to chassis joint on a Mark I coach. *Andy McConnell.*

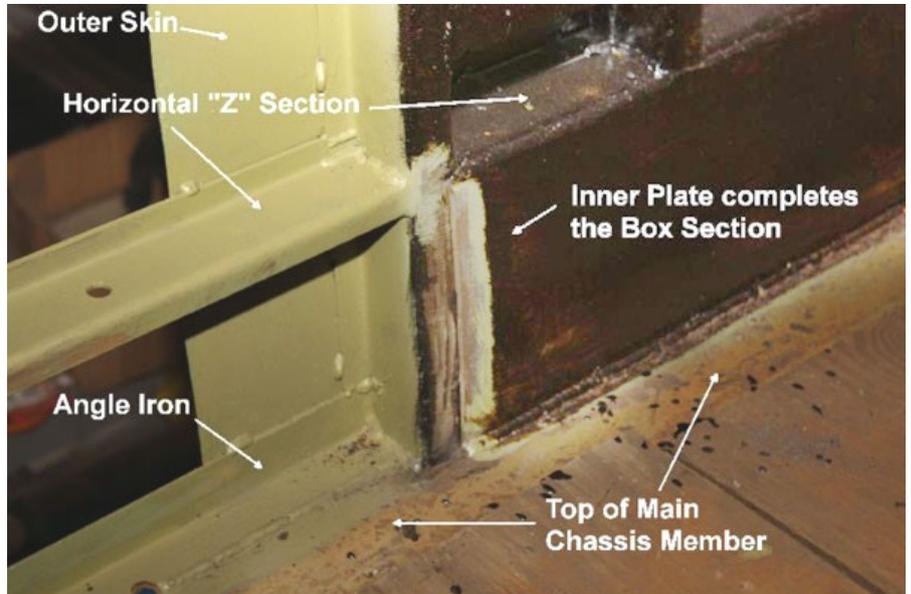
3. Body to chassis joint of Swindon DMU vehicle Sc79443 during rebuilding. It shows a partially rebuilt section effectively shows the method of construction on the left with a completed section on the right. Note that the frames and body-sides are securely joined to the chassis by the built up Box Section all along the length of the bodyside. This provides a substantial improvement in the structural integrity of the vehicle in terms of its load bearing capacity and in its crash resistance. *Andy McConnell.*
